CASE STUDY

Assessment of Irrigation at Kingsway Reserve

City of Wanneroo

Neil Lantzke
Perth NRM
February 2020

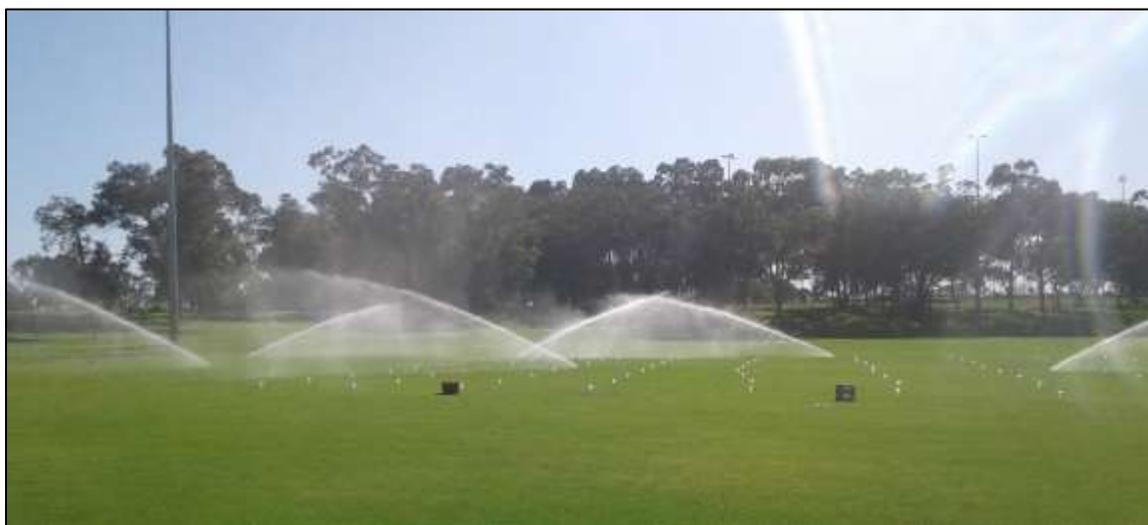
Hunter I25 sprinklers with brown jets are used to irrigate the Kingsway football oval. They are spaced in a triangular pattern at a distance of 16.5 m x 16.5 m and have an operating pressure at the sprinkler head of 500 kPa. The soil type is a Yellow Karrakatta sand which contains less than 2% clay.

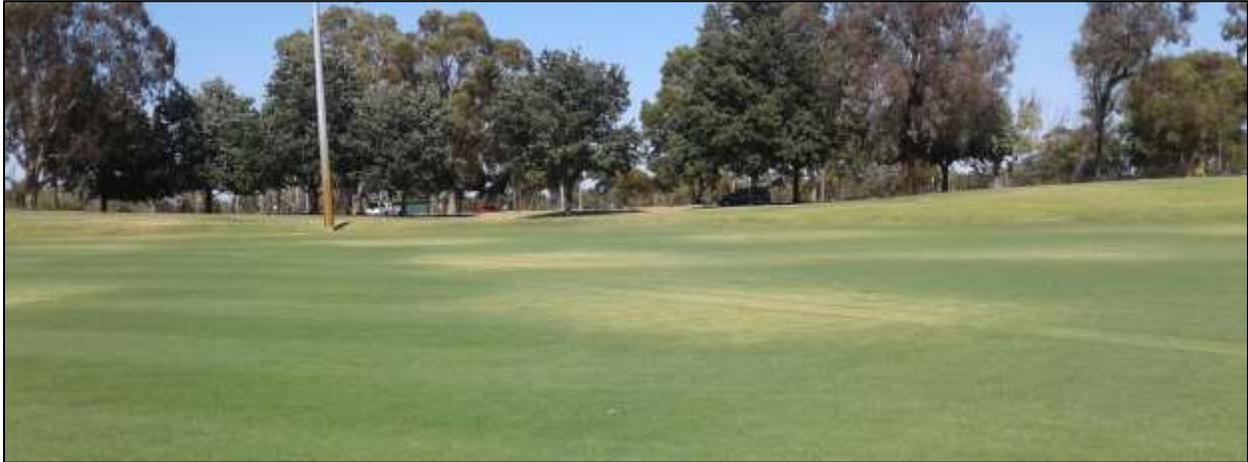
Figure 3. Dry patches on the Kingsway football oval on December 13, 2019

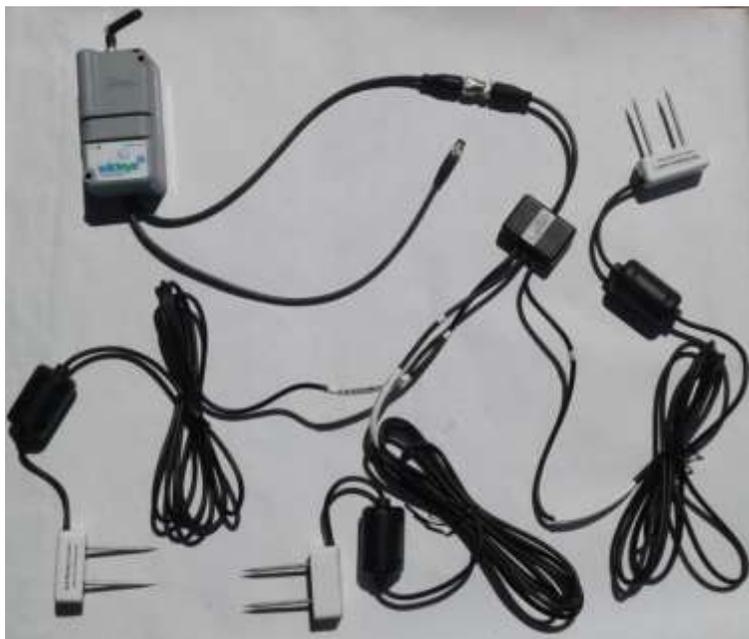
Figure 4. Teros 10 capacitance probes connected to a Wildeck logger

Teros 10 capacitance sensors were used to monitor soil moisture below the turf during the summer of 2019/20. Figure 4 shows one set of equipment with three probes and a data logger. The probes were installed at 4, 8 and 12 cm deep as it was believed that these depths corresponded with the top, middle and bottom of the main root zone.
